INDOOR AIR QUALITY ASSESSMENT

**Littleton Middle School
55 Russell Street
Littleton, Massachusetts**

Prepared by:
Massachusetts Department of Public Health
Center for Environmental Health
Emergency Response/Indoor Air Quality Program
August 2005

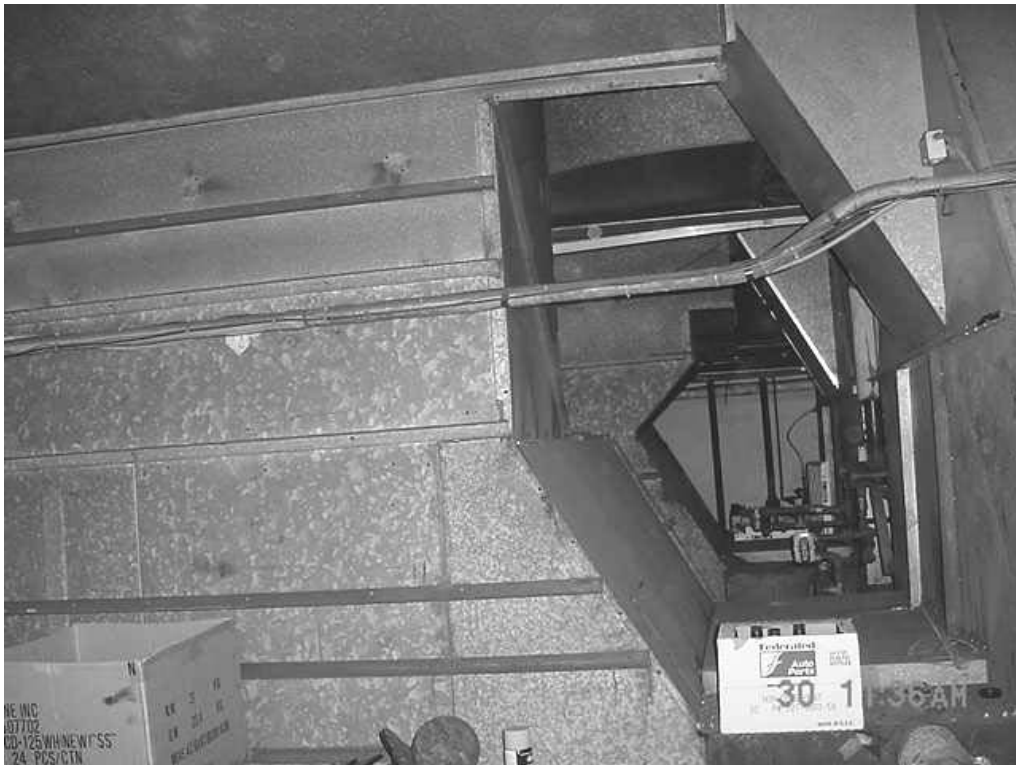
Picture 1

Air handling units (AHUs) located in the boiler room provide fresh air to classrooms (Picture 1). Fresh air is drawn through intakes on exterior walls (Picture 2), ducted through the slab and supplied to occupied spaces by wall-mounted diffusers (Picture 3). Air is ducted back to the AHUs through return vents installed in the floor (Picture 4). These systems were operating during the assessment.

Ducted Air Handling Units in Boiler Room

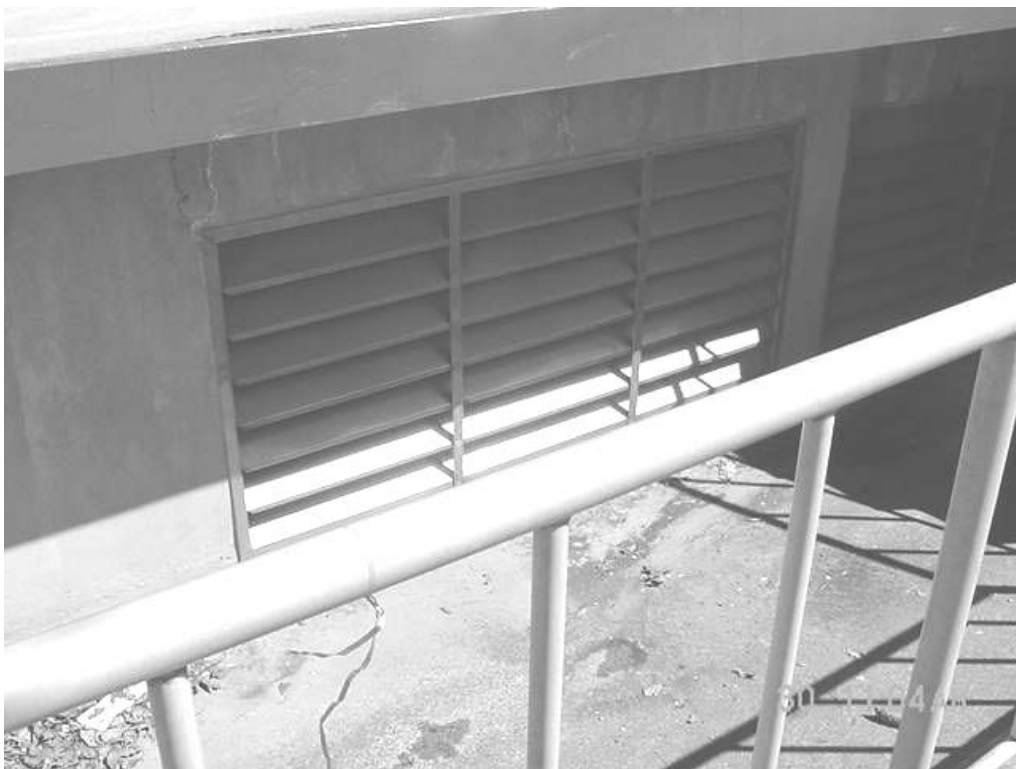
Picture 2

Fresh Air Intake Vent

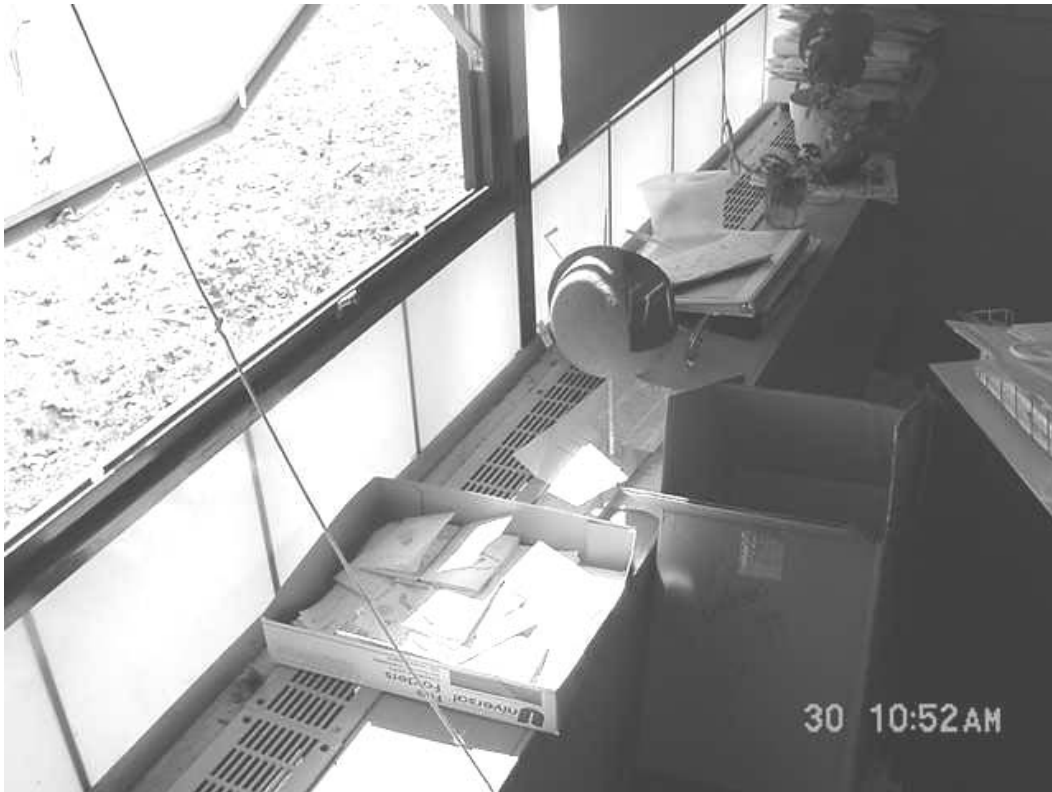
Picture 3

Wall-Mounted Supply Vents along Window Frames

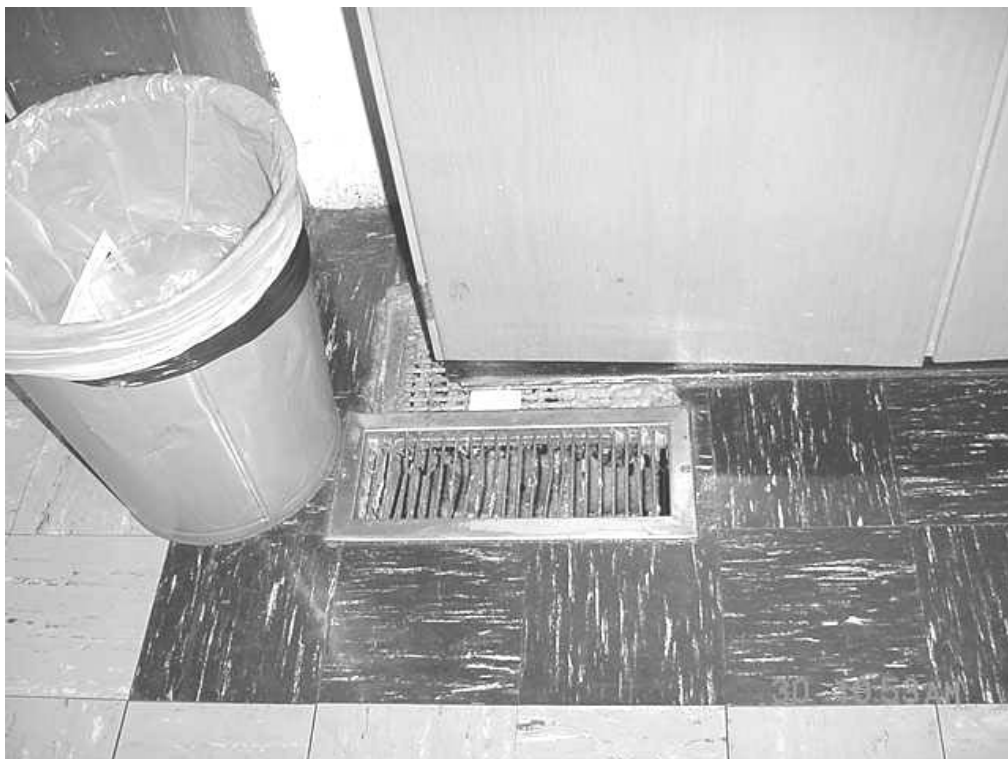
Picture 4

Floor Return Vent

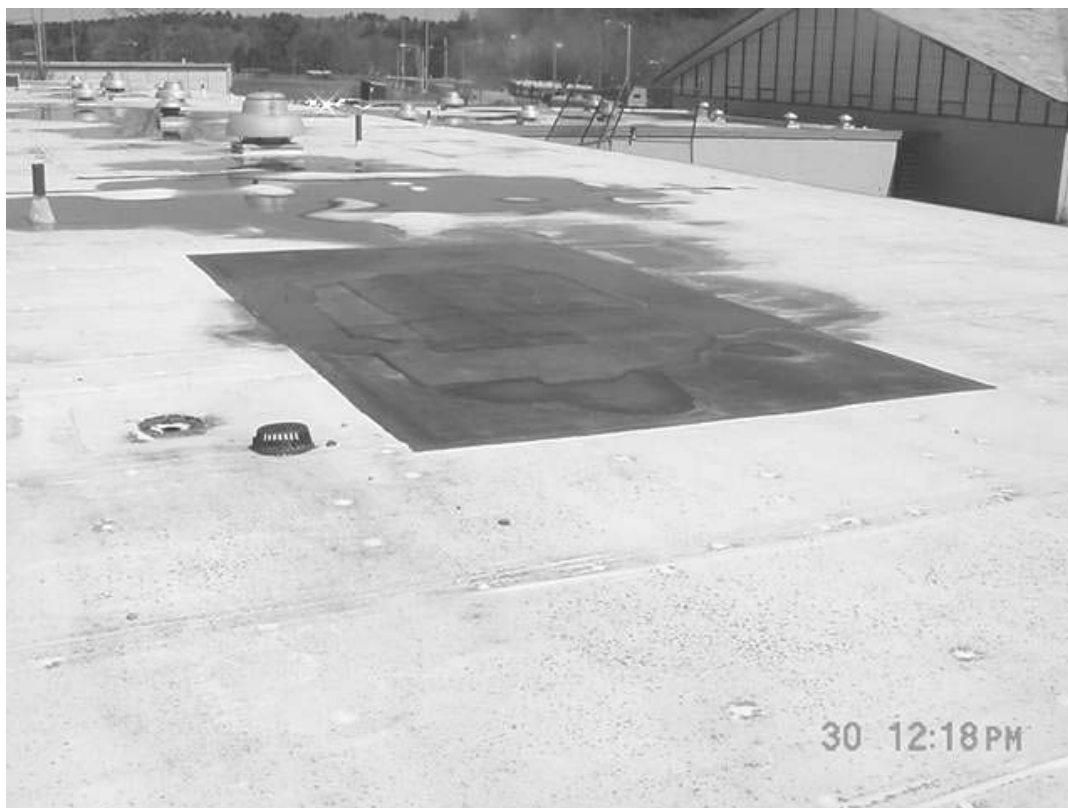
Picture 5

The building has a history of chronic roof leaks, despite efforts to replace sections or patch areas over the years (Pictures 5 and 6). Active roof leaks were observed in several areas during the assessment. In an effort to collect water, buckets, barrels and other reservoirs were in use throughout the building (Picture 7). Current and historic roof leaks are a result of pooling water on the roof (Pictures 8 and 9). MDPH staff examined the roof and found the roof surface to be rippled and bulging in various areas (Picture 9).

Large Roof Patch

1. Ensure LPS maintenance staff continue to monitor for active leaks, considering current conditions of the roof. School occupants should continue to notify the main office if leaks are observed for prompt action.
2. Continue working with roofing contractor in making roof repairs/patches as needed to prevent further water penetration.
3. Empty buckets used to collect leaks regularly to prevent standing water, mold growth and associated odors. Clean and disinfect buckets and surface areas around leaks with an appropriate anti-microbial as needed.
4. Repair/replace exterior doors to boiler room to prevent/reduce water infiltration.

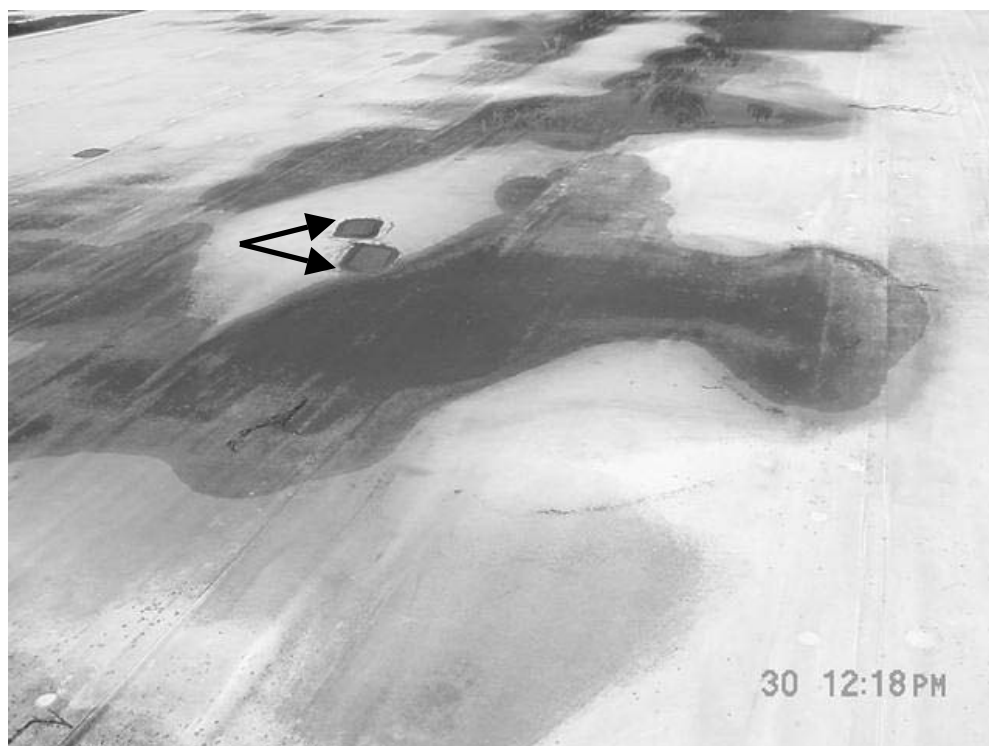
Picture 6

Small Roof Patches

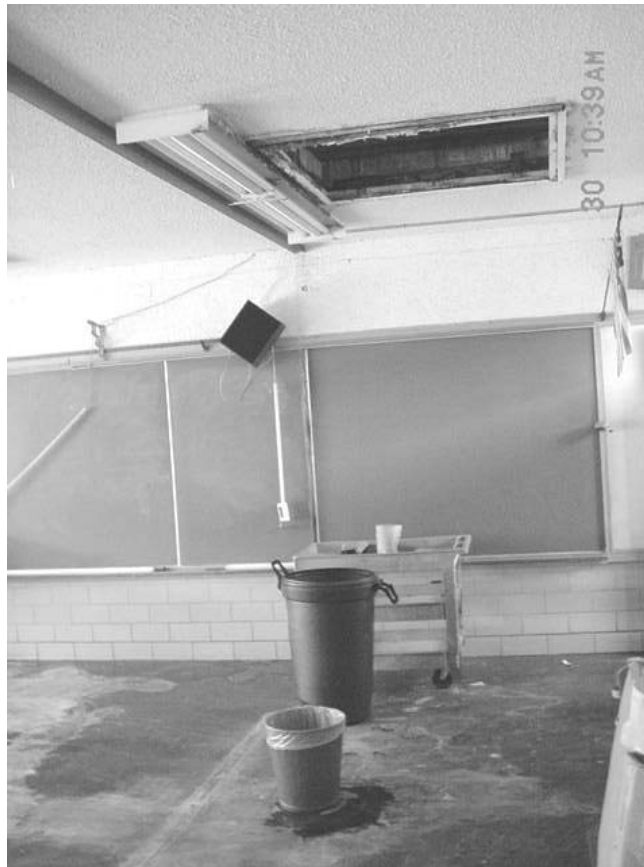
Pictures 7

Barrel and Bucket Stationed to Catch Roof Leaks

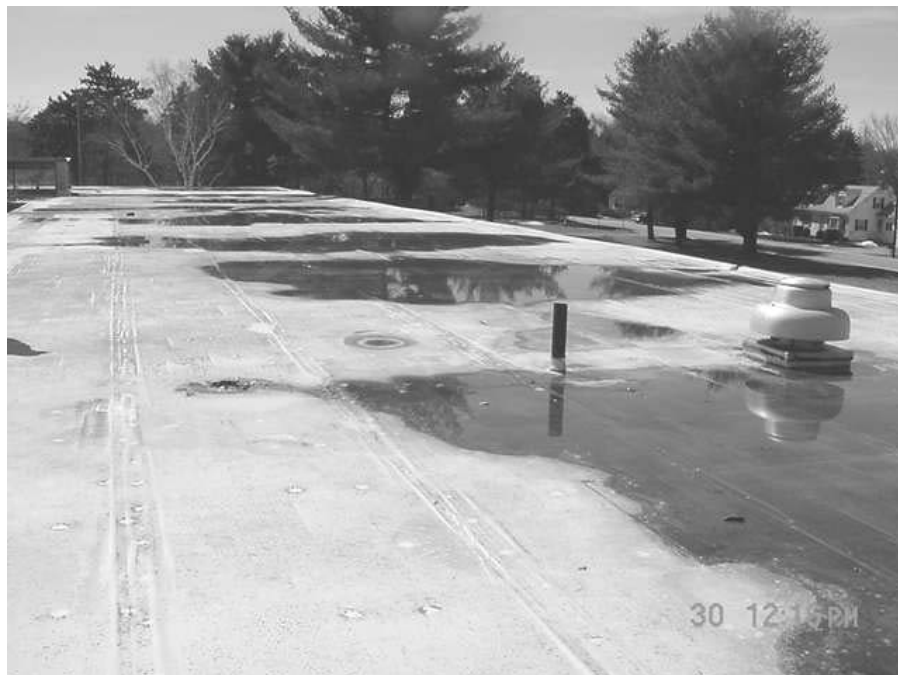
Picture 8

Water Pooling on Roof

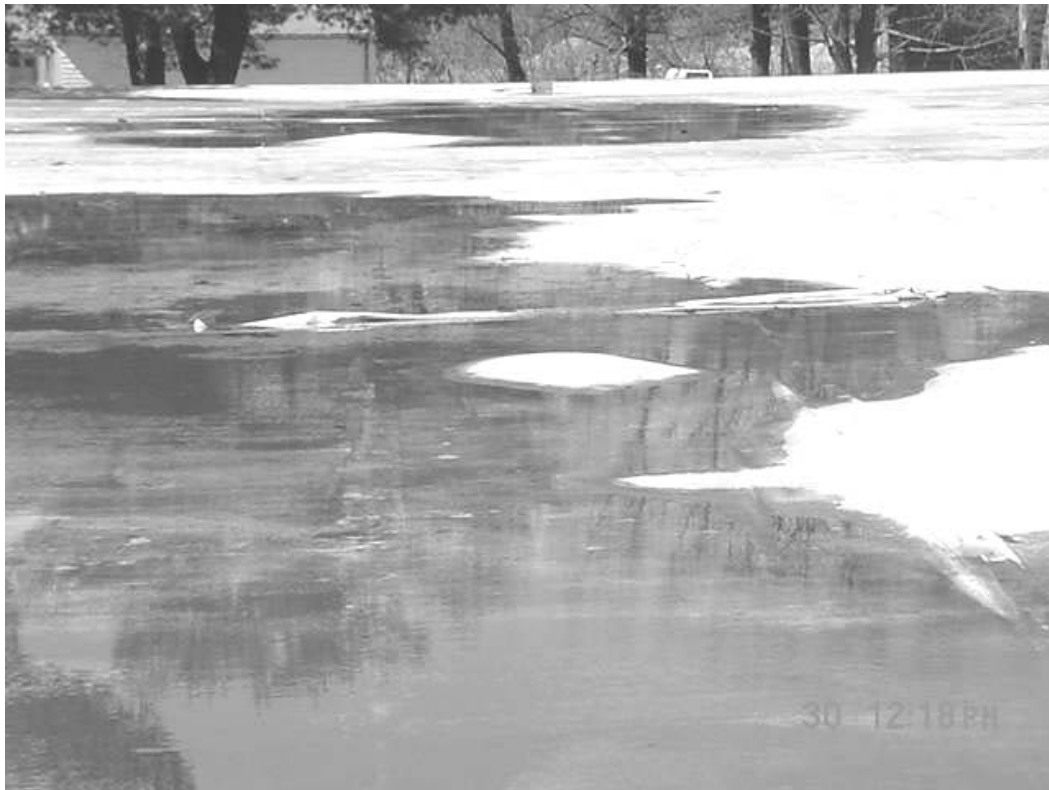
Picture 9

Water Pooling on Roof, Note Uneven Surface and “Raised” Areas

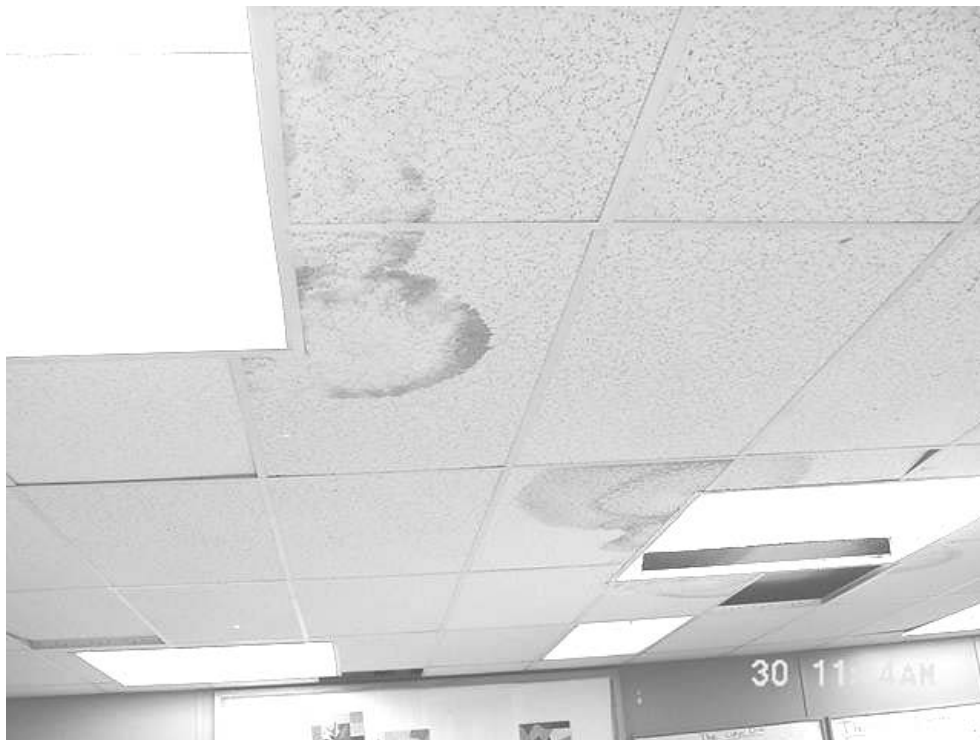
Picture 10

Missing and/or water-damaged ceiling tiles and other building materials were observed throughout the building (Pictures 10 through 12). Water-damaged porous building materials (e.g., ceiling tiles) can provide a source of mold growth and should be replaced after a water leak is discovered and repaired.

Missing/Water Damaged Ceiling Tiles in Library

5. Replace/remove severely water-damaged ceiling tiles. Examine the area above and around these areas for mold growth. Disinfect areas of water leaks with an appropriate antimicrobial.

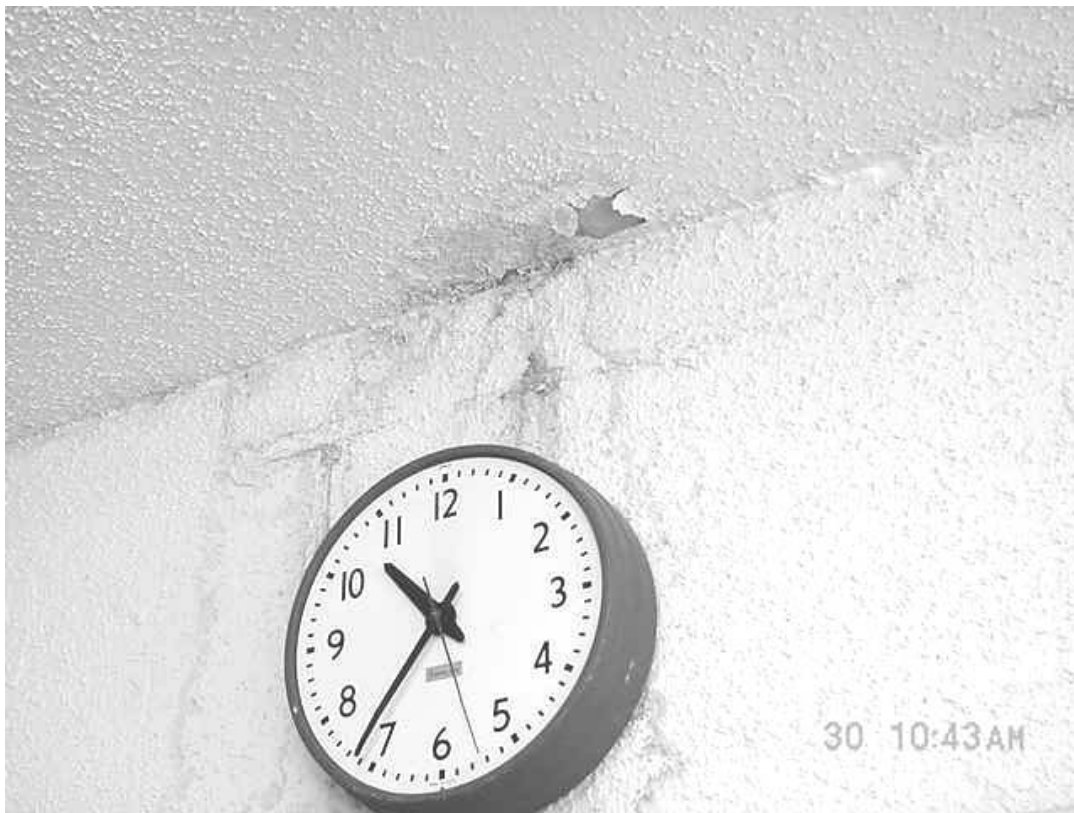
Picture 11

Water Damaged Ceiling/Wall Plaster

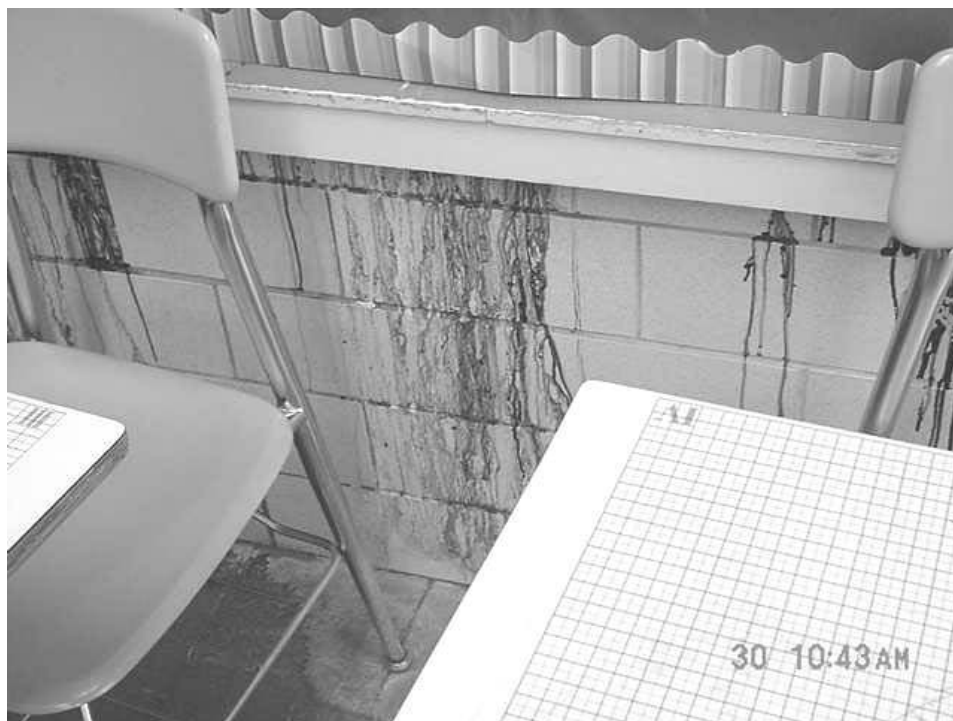
Picture 12

Water Staining on Wall

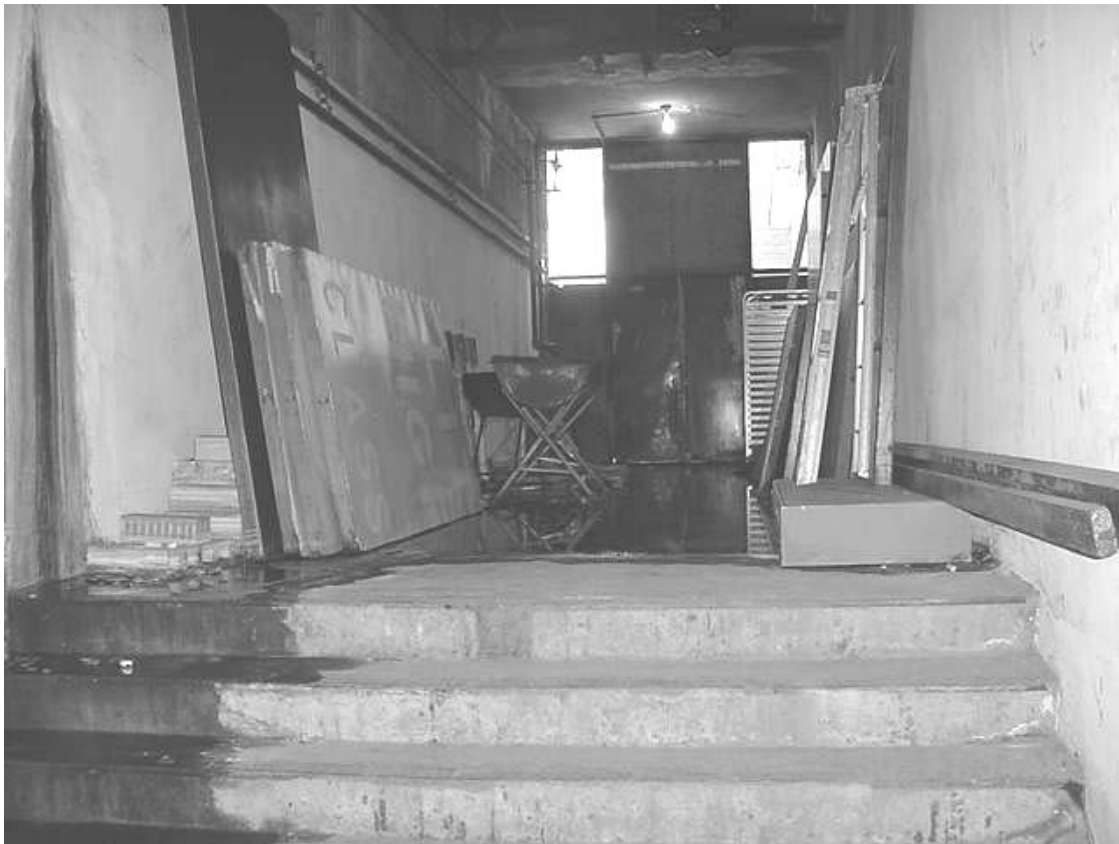
Picture 13

Another major pathway for water penetration into the building included damage to exterior walls and doors. Evidence of severe water penetration into the subterranean boiler room was observed (Pictures 13 through 16). Portions of the basement are used for storage. Because of standing water, some of the stored items were moistened. Porous materials that can support mold growth, such as wooden pallets, cardboard, paper and other items appeared to be colonized with mold (Pictures 17 through 19). The US Environmental Protection Agency (US EPA) and the American Conference of Governmental Industrial Hygienists (ACGIH) recommend that porous materials be dried with fans and heating within 24 to 48 hours of becoming wet (US EPA, 2001; ACGIH, 1989). If porous materials are not dried within this time frame, mold growth may occur. Water-damaged porous materials cannot be adequately cleaned to remove mold growth. The application of a mildewcide to moldy porous materials is not recommended.

Water Penetration through Exterior Door and Down Stairs into the Boiler Room

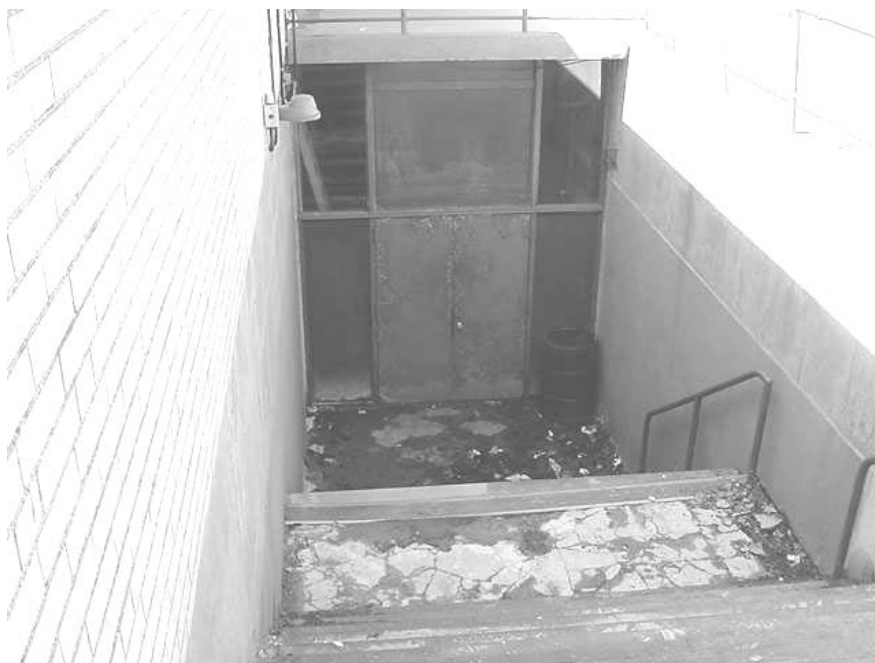
Picture 14

Exterior View of Boiler Room Door

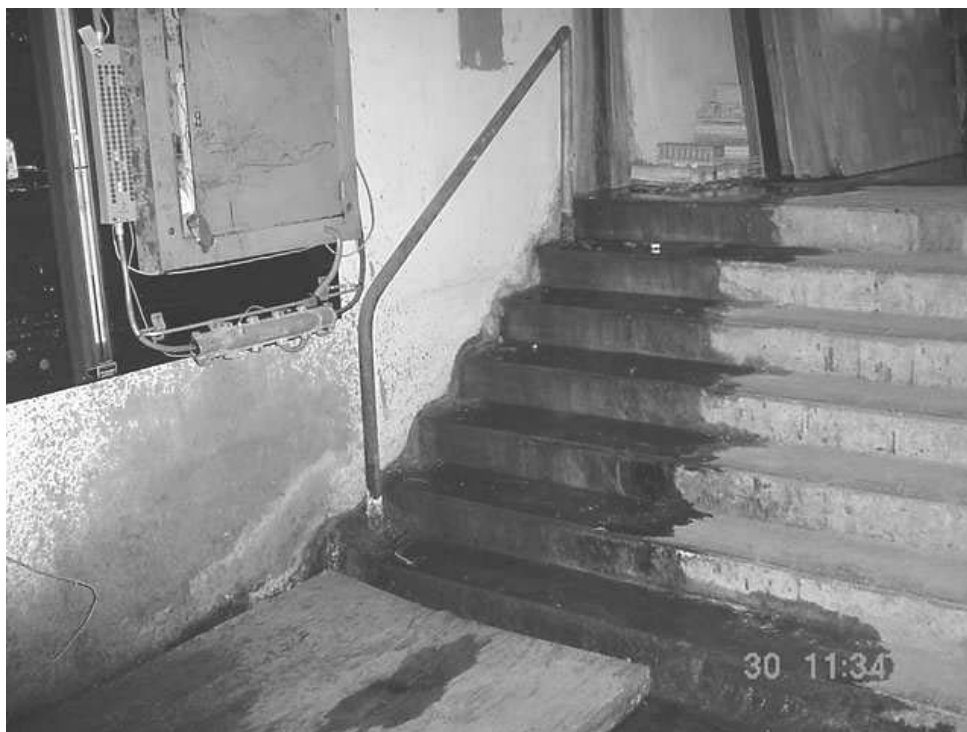
Picture 15

Water Penetration down Stairs into Boiler Room

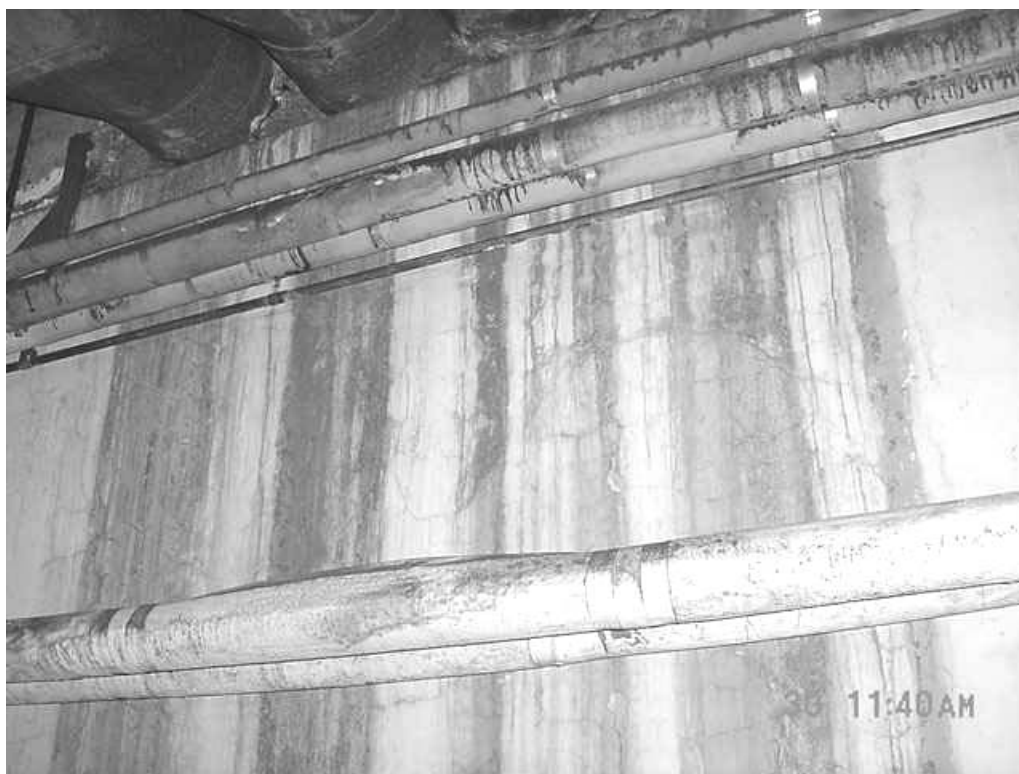
Picture 16

Water Penetration down Foundation Wall of Boiler Room

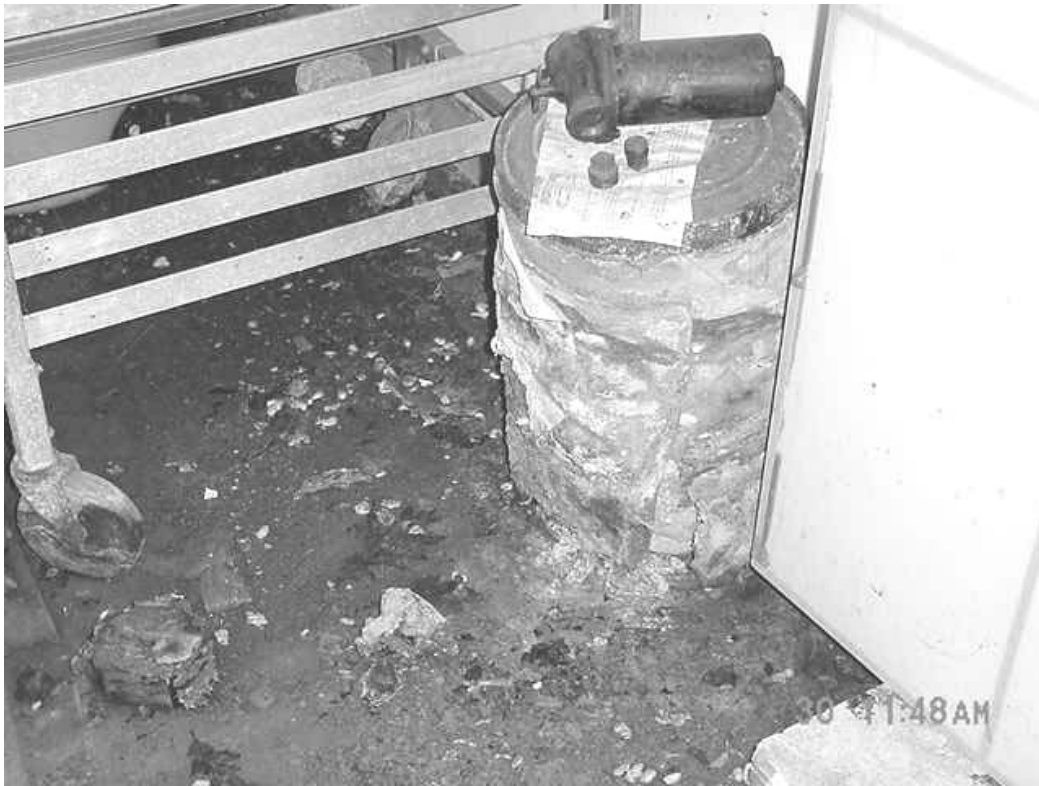
Picture 17

Water Damaged/Mold Colonized Porous Materials Stored in the Boiler Room

1. *Ensure that the general mechanical ventilation system is **deactivated** and that any openings (e.g., vents, breaches) are sealed during remediation.* Discard stored materials and building materials that appear to have mold contamination. This measure will remove actively growing mold colonies that may be present. Remove mold contaminated materials in a manner consistent with recommendations in “Mold Remediation in Schools and Commercial Buildings” published by the US Environmental Protection Agency (US EPA, 2001). Copies of this document can be downloaded from the US EPA website at:
http://www.epa.gov/iaq/molds/mold_remediation.html.

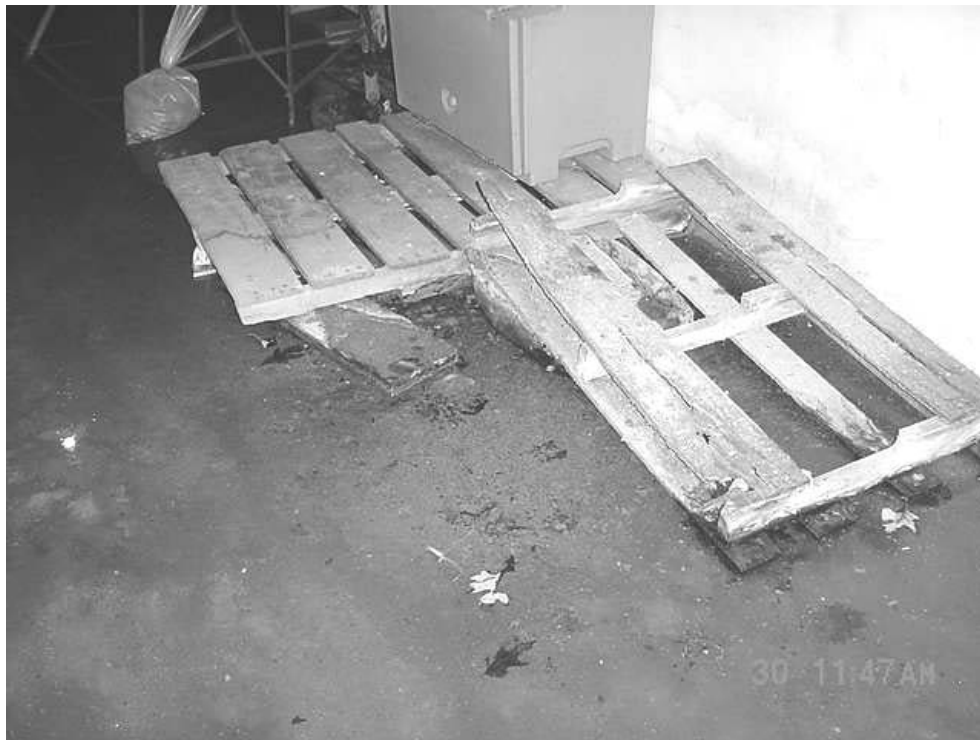
Picture 18

Water Damaged/Mold Colonized Wooden Pallets Stored in the Boiler Room

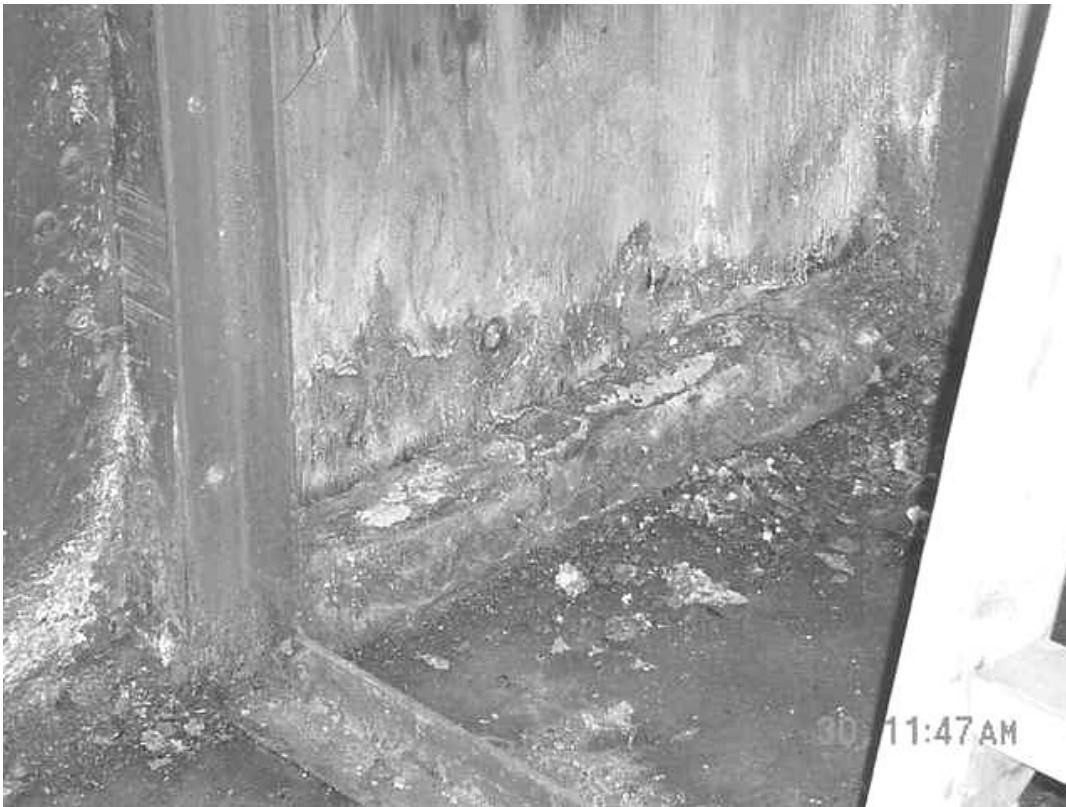
Picture 19

Water Damaged/Mold Colonized Plywood and Debris in the Boiler Room

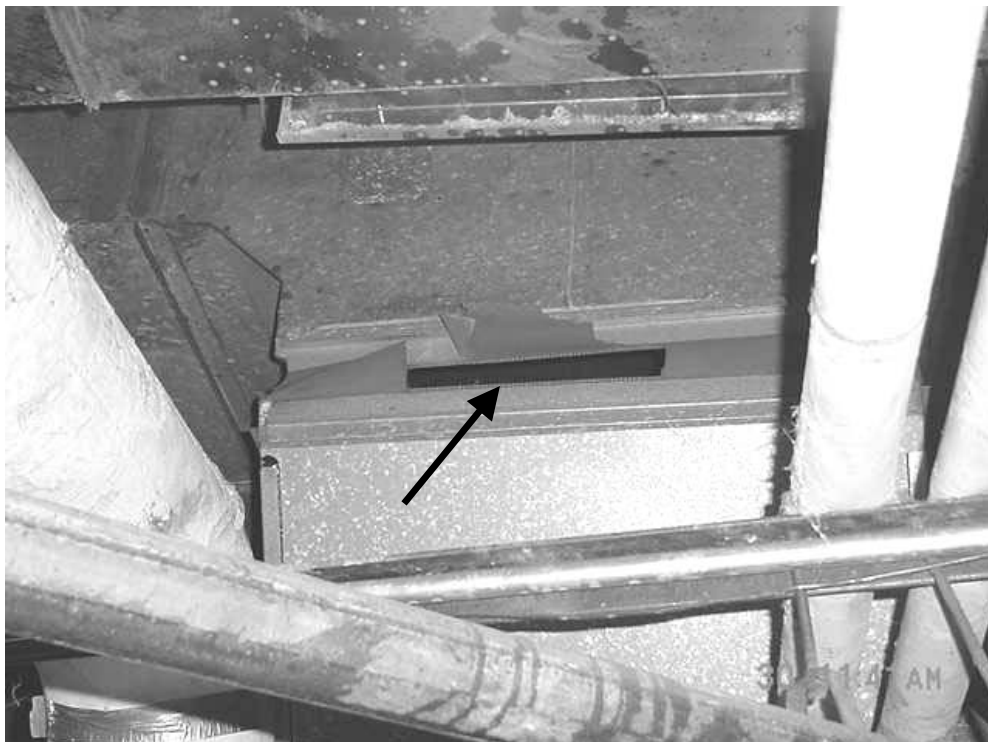
Picture 20

Potential means for the movement of musty odors and particulates from the boiler room to enter occupied areas of the building were identified. The most obvious pathway was through breaches in ductwork (Picture 20). At the time of the assessment, measures to prevent chronic water penetration into the boiler room were not feasible; however, MDPH staff recommended the removal of all water-damaged materials from the boiler room as well as the sealing of breaches in ductwork to avoid entrainment of odors and particulates into the ventilation system.

Breach in Ductwork (Boiler Room)

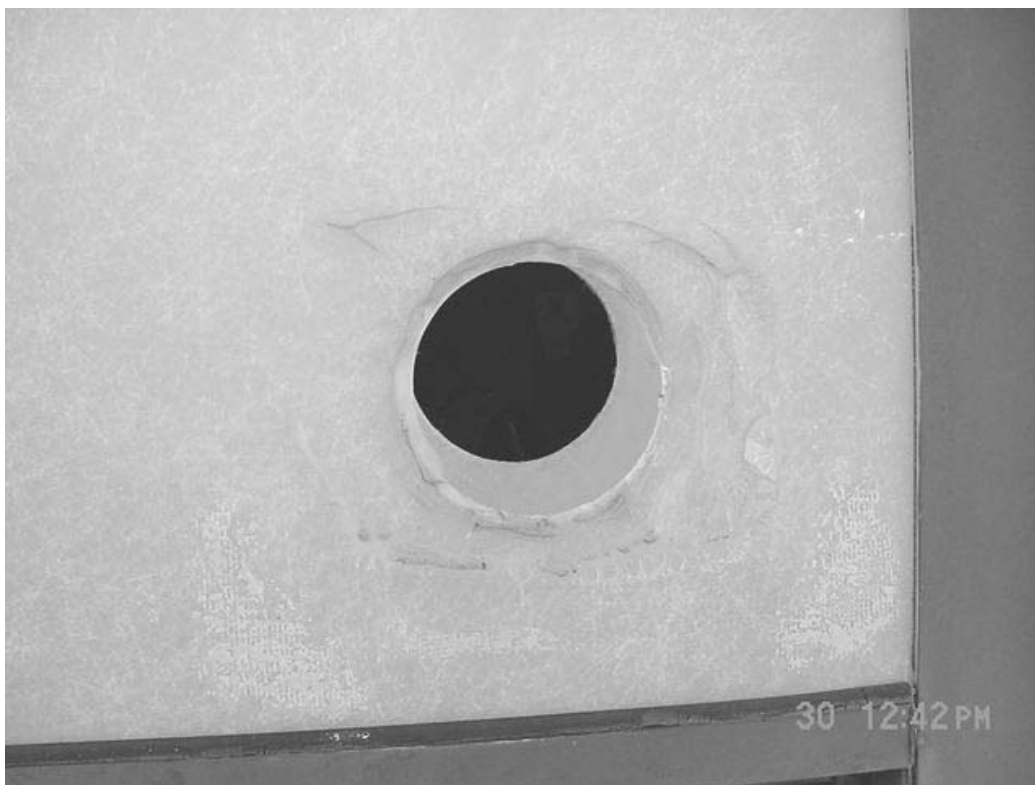
Picture 21

Other potential pathways for moisture to enter into the building include open holes (Picture 21), missing/damaged mortar on exterior walls (Picture 22) and missing/damaged caulking around window and door frames (Pictures 23 through 25). These breaches to the building envelope can allow water to penetrate the building. Repeated water penetration can result in the chronic wetting of building materials and potential microbial growth. In addition, these holes may provide a means of egress for pests/rodents into the building.

Open Hole in Plexiglas Window, Science Wing (Reportedly for Flammables Cabinet)

5. Repair/replace broken windows; re-seal loose window frames to prevent drafts and water penetration. Seal hole in window in science wing.
6. Install elbow extensions on downspouts to direct rain water away from the building.
7. Contact a masonry firm or general contractor to repair holes/breaches in exterior walls/joints to prevent water penetration, drafts and pest entry.

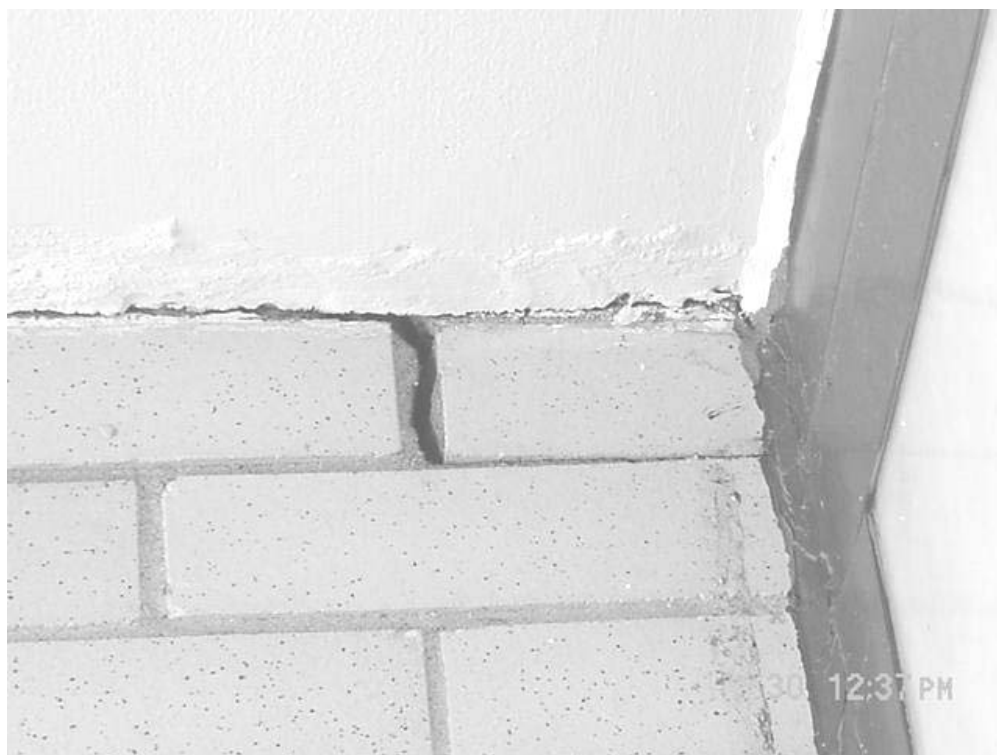
Picture 22

Missing/Damaged Mortar around Exterior Brick

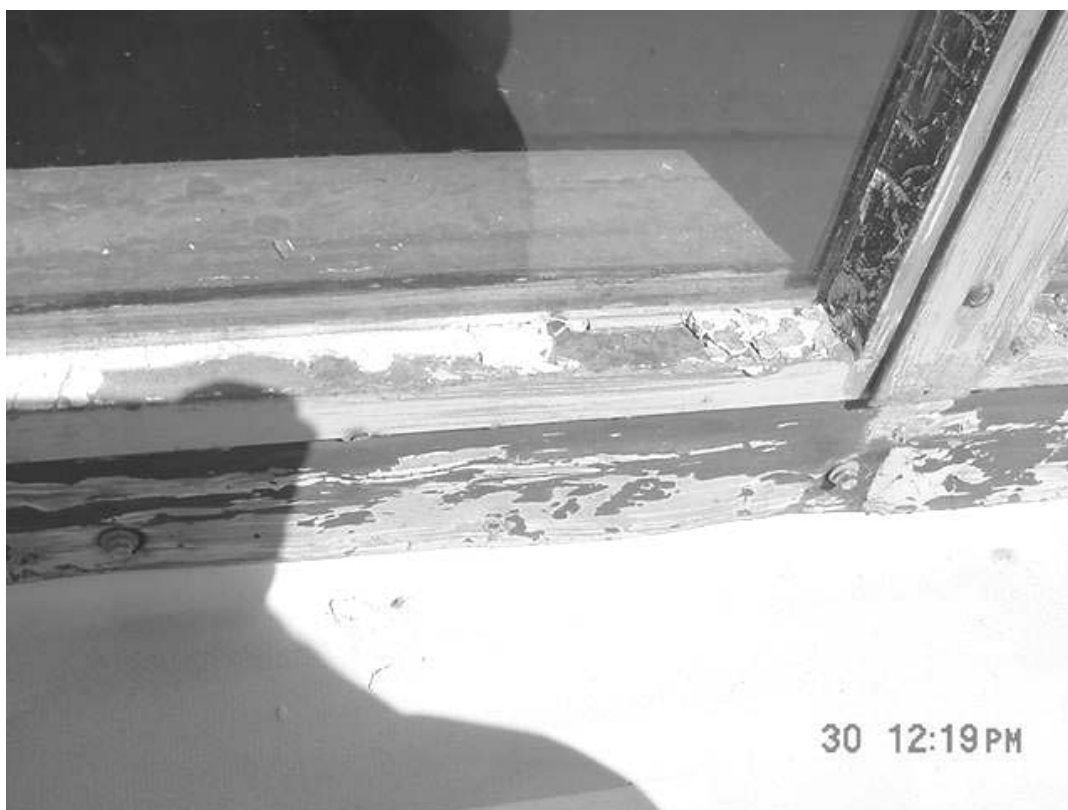
Picture 23

Missing/Damaged Caulking around Window Panes

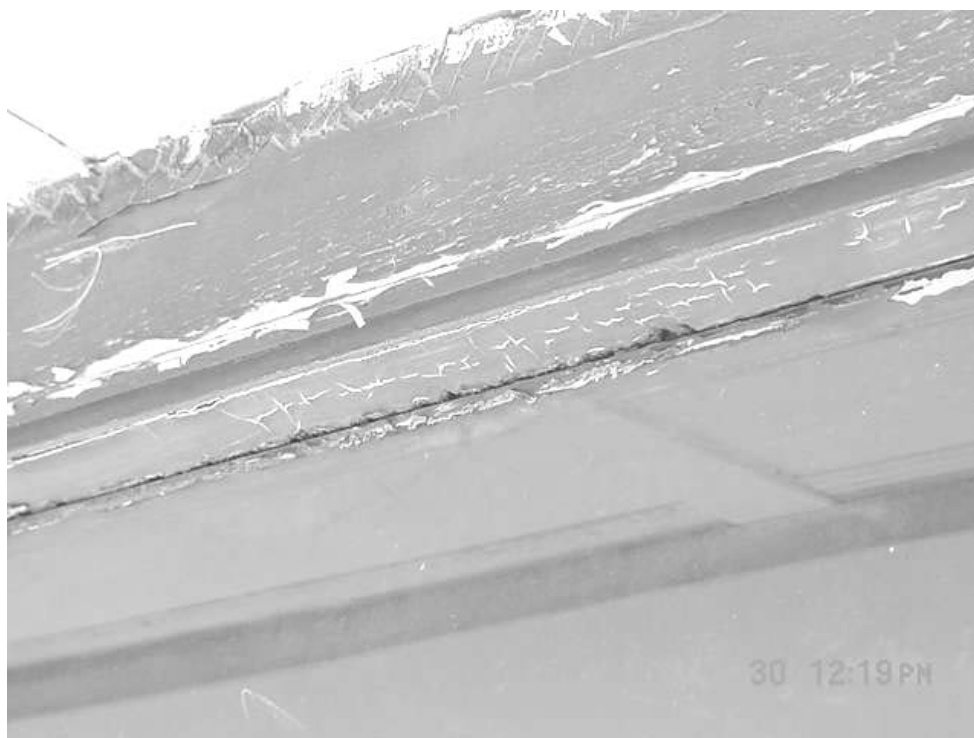
Picture 24

Missing/Damaged Caulking around Window Panes

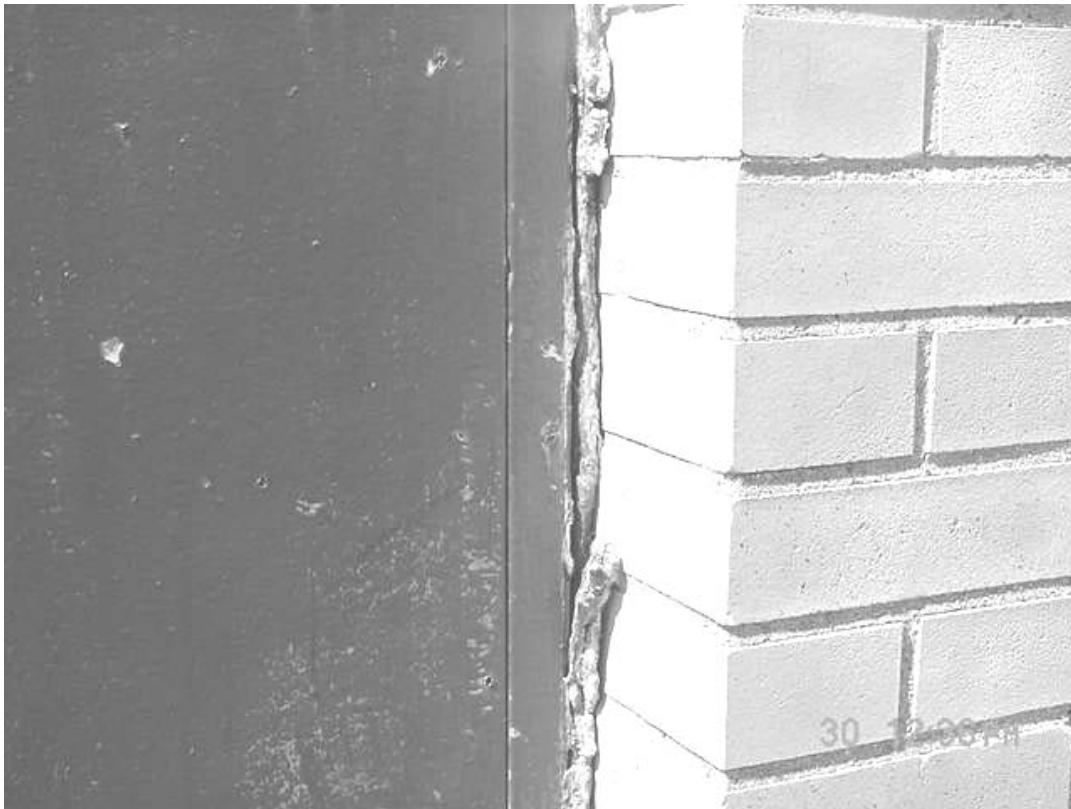
Picture 25

Missing/Damaged Caulking around Door Frame

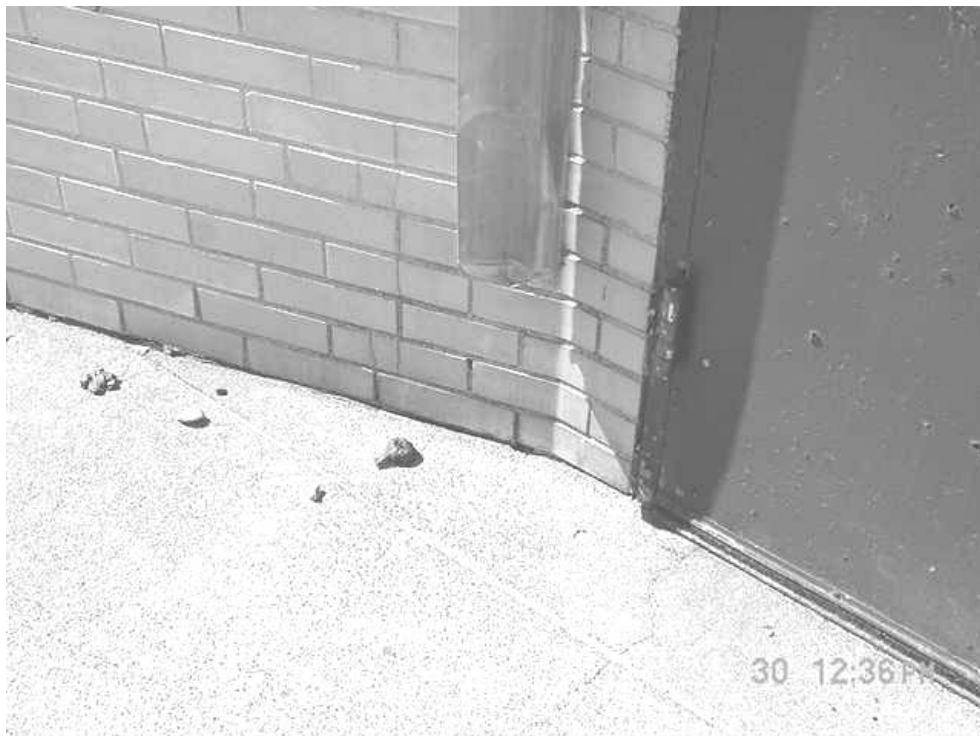
Picture 26

The building is equipped with gutters and downspouts to drain rainwater away from the building. Several downspouts were missing elbows, causing water to empty and pool against the foundation (Picture 26). Excessive exposure of exterior brickwork to water can result in damage over time. During winter weather, the freezing and thawing of moisture in bricks can accelerate the deterioration of brickwork, which can lead to water intrusion.

Downspout Missing Elbow Extension

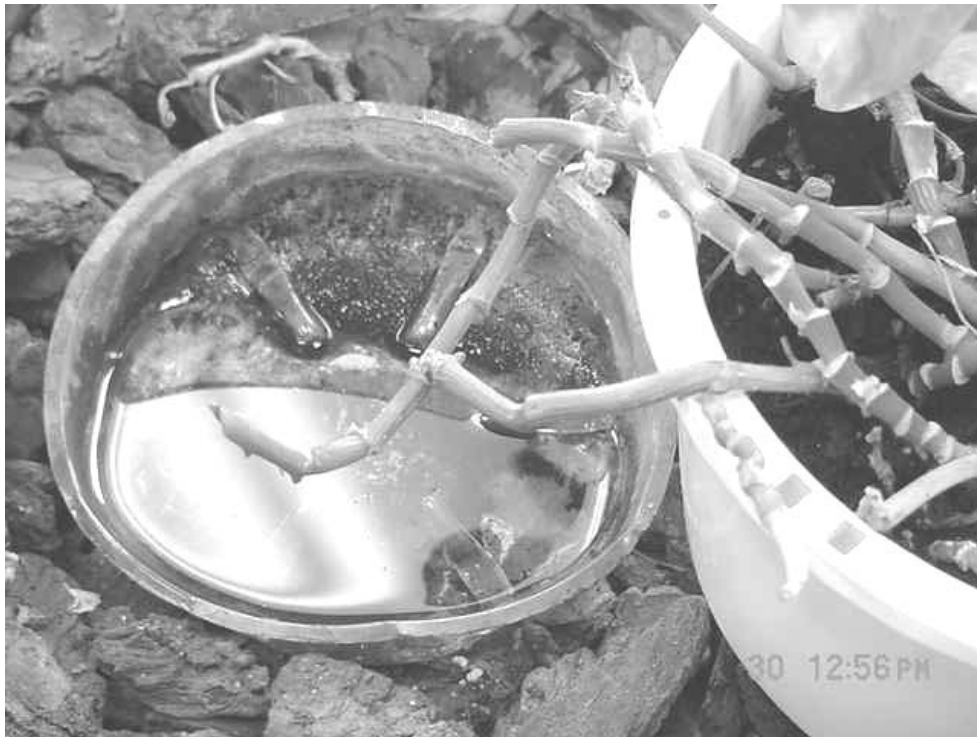
Picture 27

Several areas had a number of plants. Moistened plant soil and drip pans can be a source of mold growth (Picture 27). Of particular note was a large indoor planter in the main lobby (Picture 28). This large indoor planter is constructed of brick and did not appear to have a means for drainage. Plants are also a source of pollen. Over watering of plants should

Plant with Standing Water in Pot

6. Ensure all plants are equipped with drip pans. Avoid over watering and examine drip pans periodically for mold growth. Disinfect with an appropriate antimicrobial where necessary. Move plants away from ventilation sources in classrooms.
